Evaluation and Repair of Wrought Iron and Steel Structures in Indiana

Final Report

FHWA/IN/JTRP – 2004/4

School of Civil Engineering
Purdue University

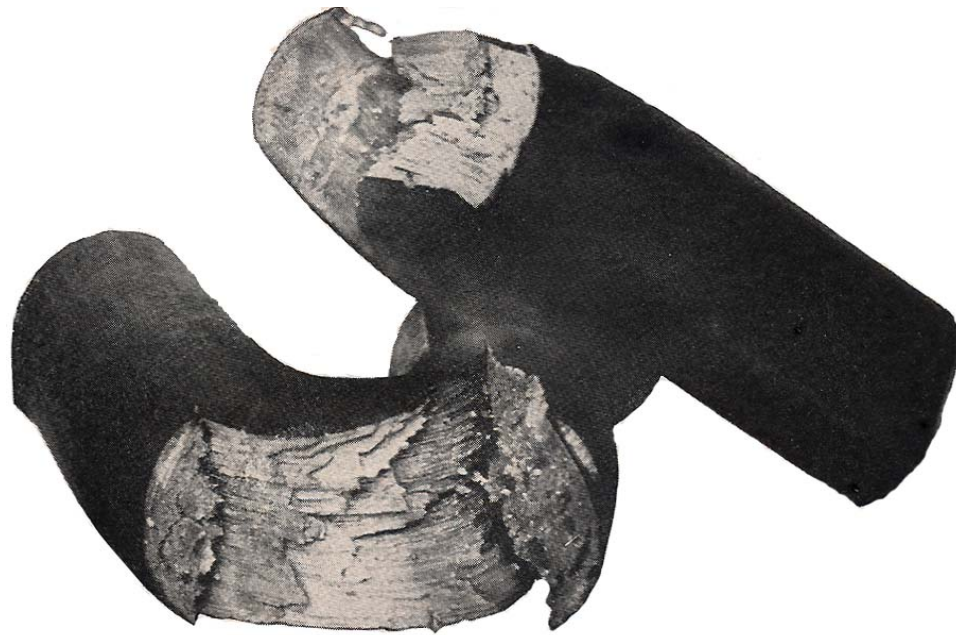
Figure 2.1 Fracture Showing Fibrous Nature of Wrought Iron. (Aston, 1949)

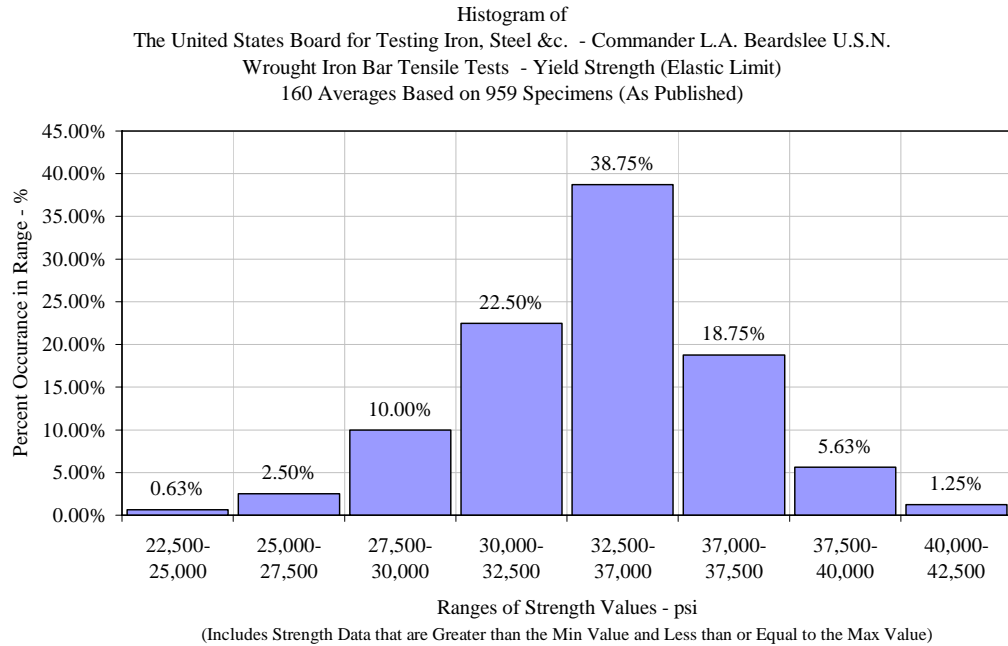
Figure 2.11 Yield Strength of Wrought Iron Bars Tested by Beardslee

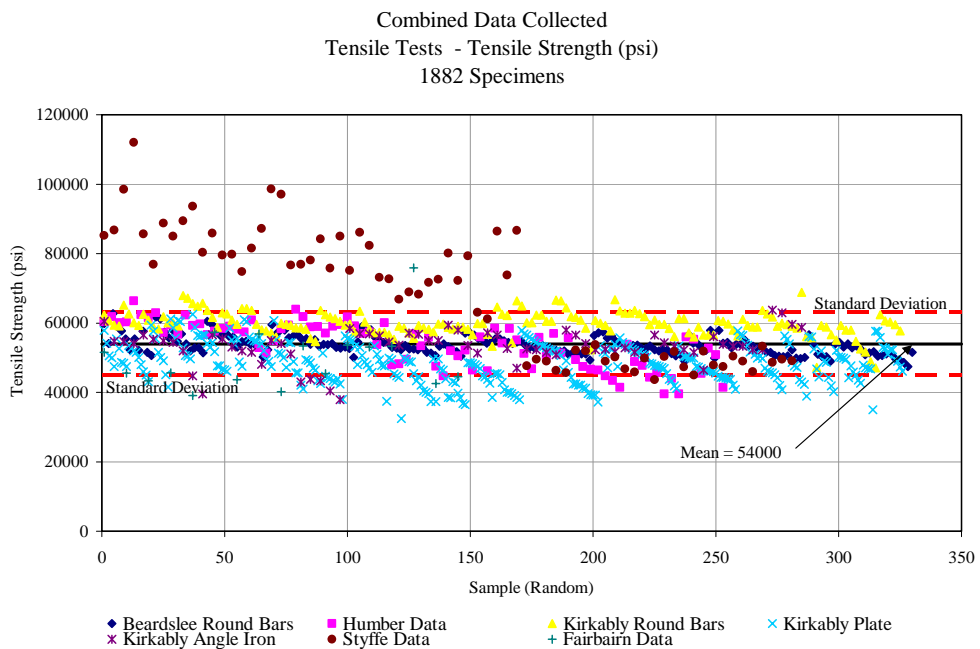
Figure 2.13 Tensile Strength of all the Data Combined

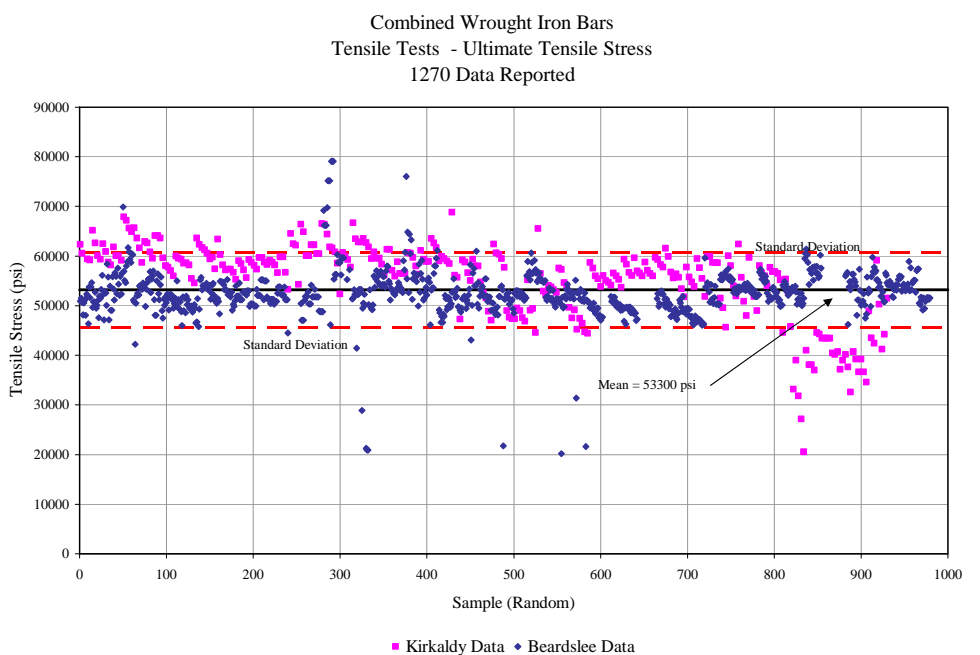
Figure 2.14 Tensile Strength of all the Bar Data Combined

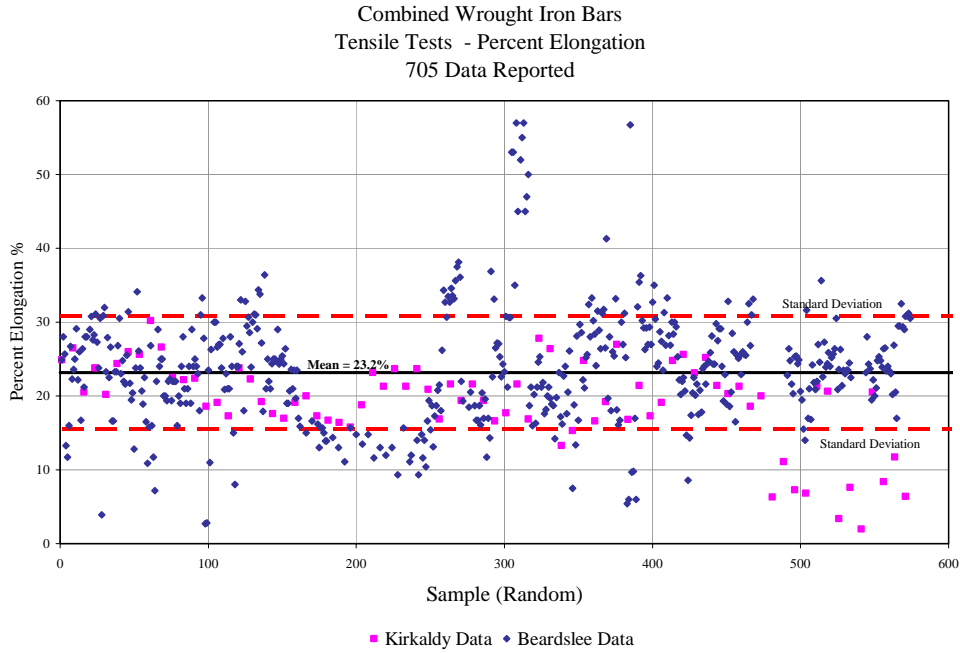
Figure 2.15 Percent Elongation of all the Bar Data Combined

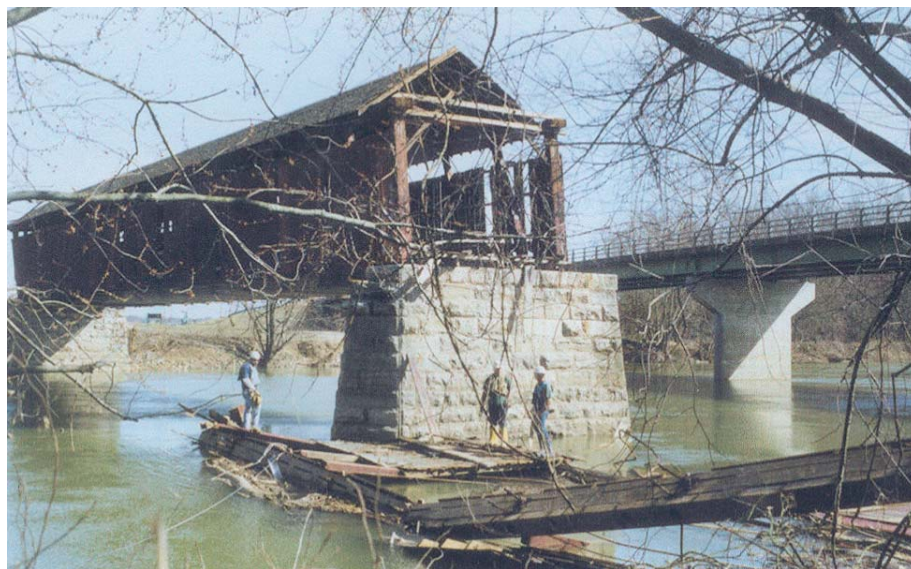
Figure 3.1 Bell Ford Bridge After Collapse of One Span

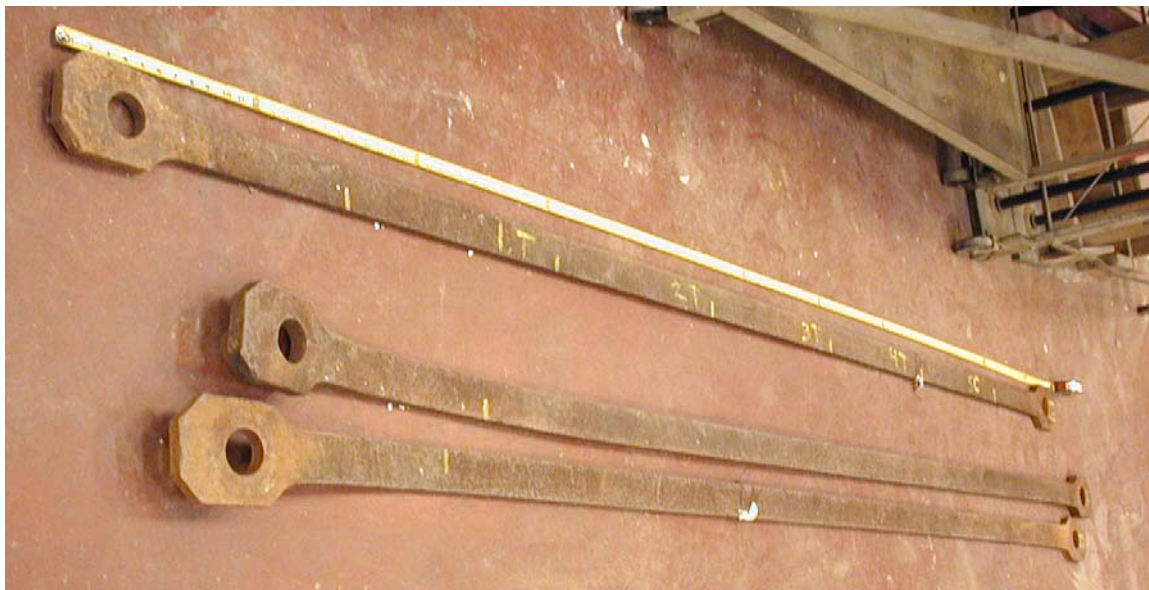
Figure 3.3 Donated Eyebars 4 and 5 Along With a Similar Eyebar that Was Straightened and Used in the Reconstruction of the Bell Ford Bridge

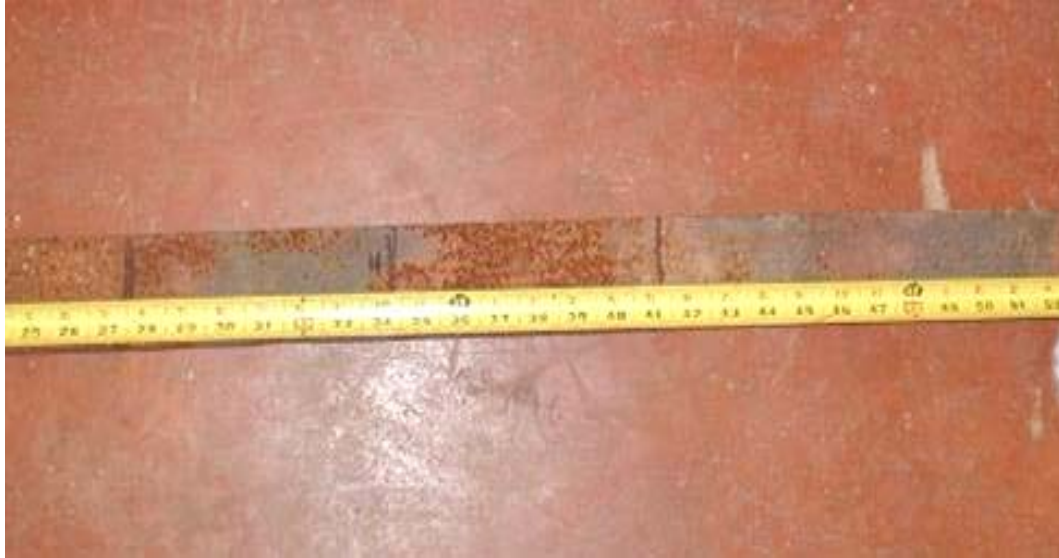
Figure 3.7 Heated Areas in Blue on Eyebar 2

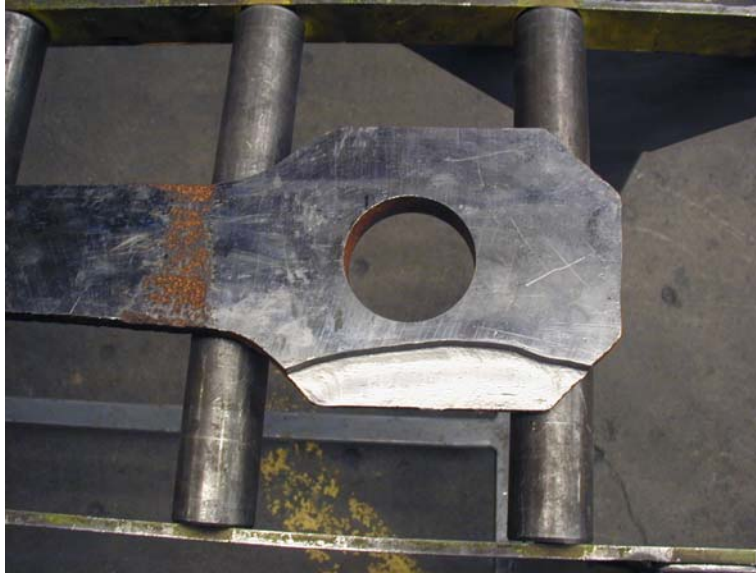
Figure 3.25 Eyebar Connection A After Material Was Removed to Simulate Corrosion

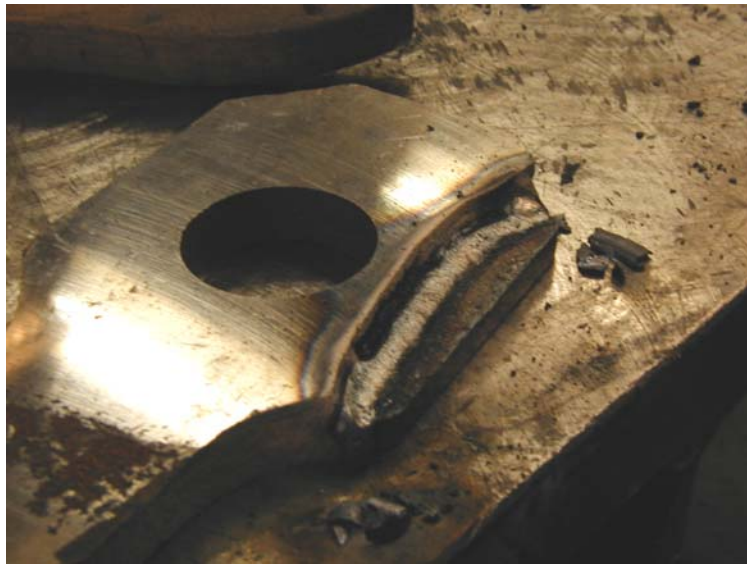
Figure 3.26 Initial Filler Weld Pass on Eyebar Connection A

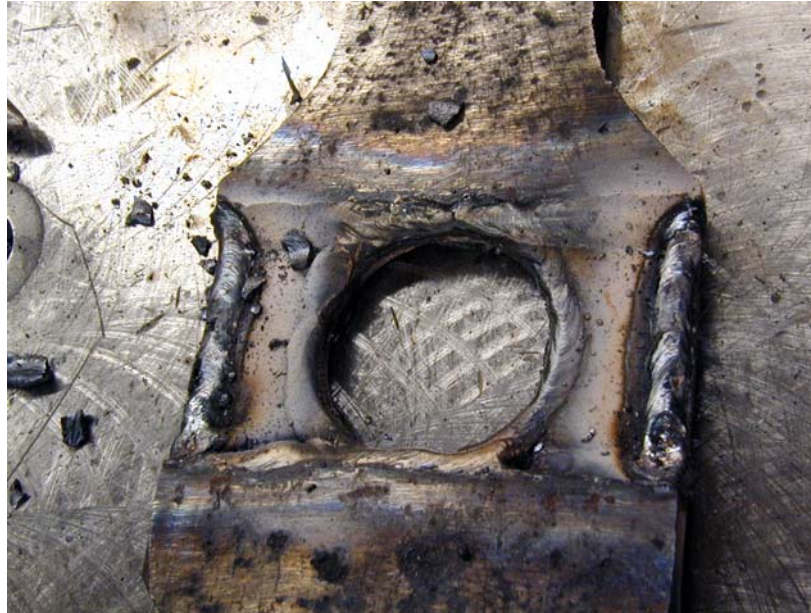
Figure 3.29 Initial Filler Weld Passes on Eyebar Connection B

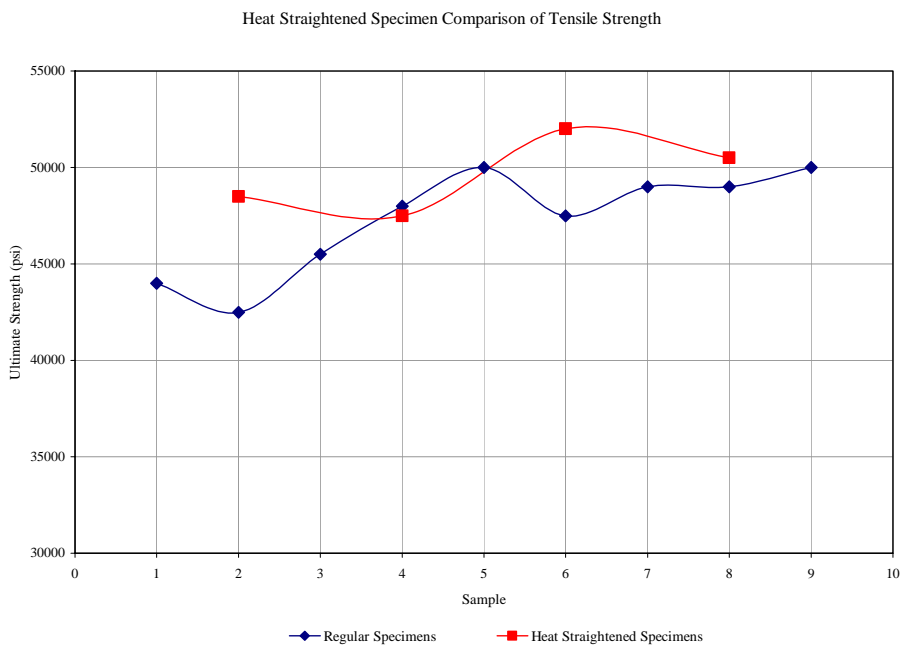
Figure 4.14 Comparison of Heated Straightened Specimens for Tensile Strength

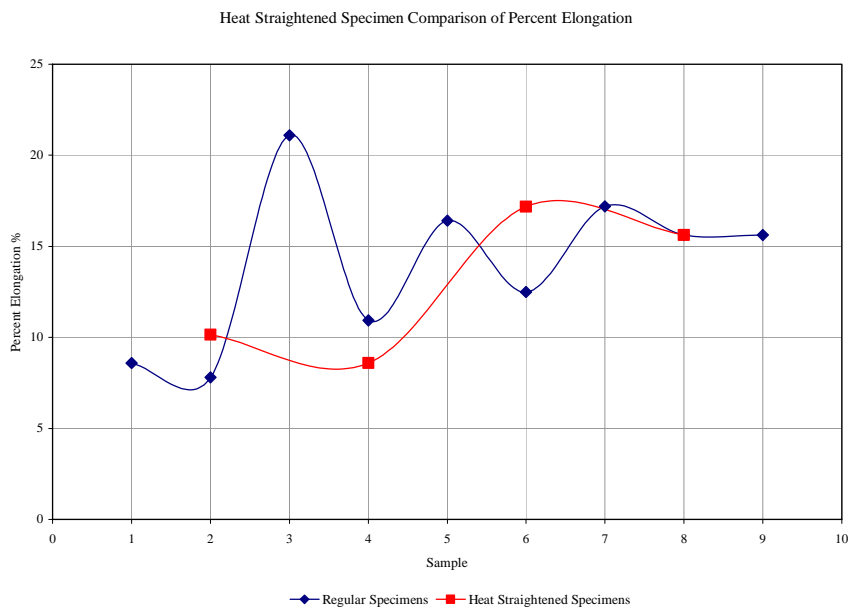
Figure 4.15 Comparison of Heated Straightened Specimens for Percent Elongation

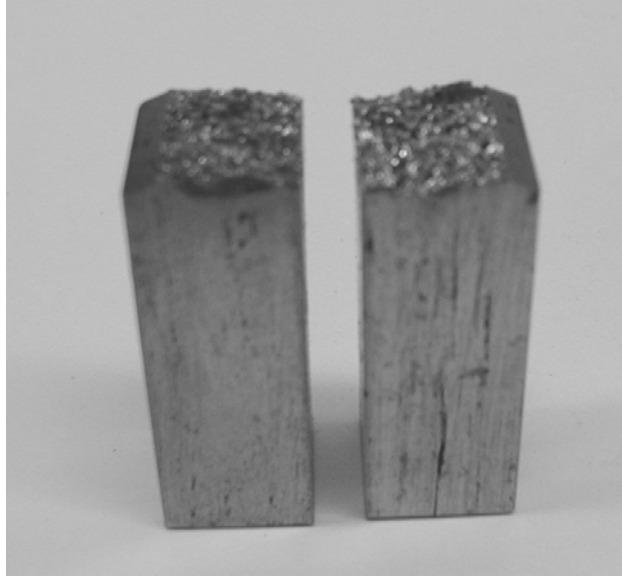
Figure 4.21 Cleavage Fracture of Charpy Impact Specimen (LU, LS Type)

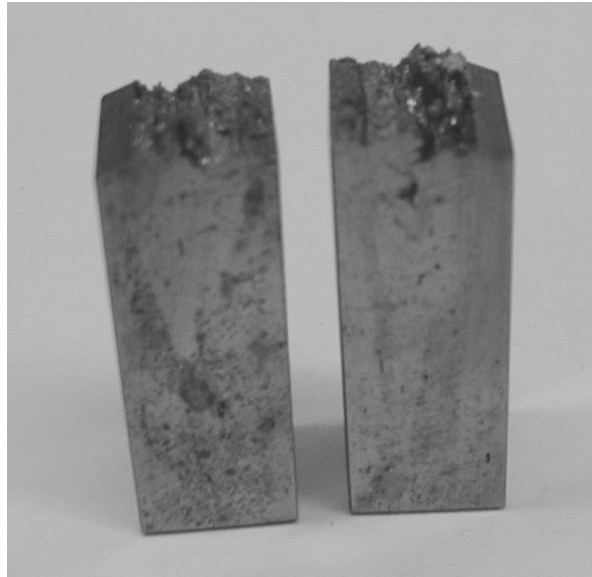
Figure 4.22 Slip Plane Fracture of Charpy Impact Specimen (T Type)

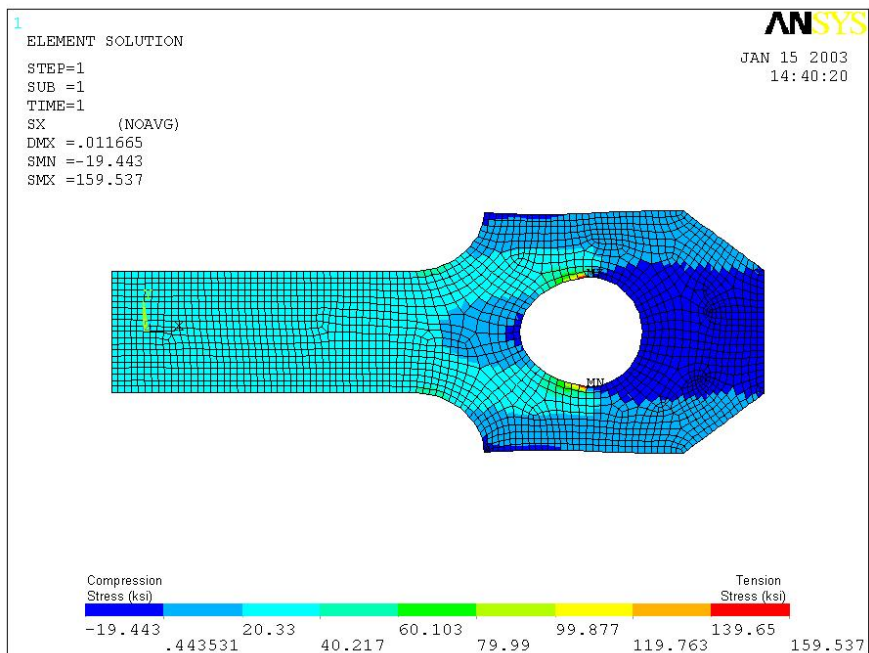
Figure 4.23 Stresses in the Eye Connection by Finite Element Analysis

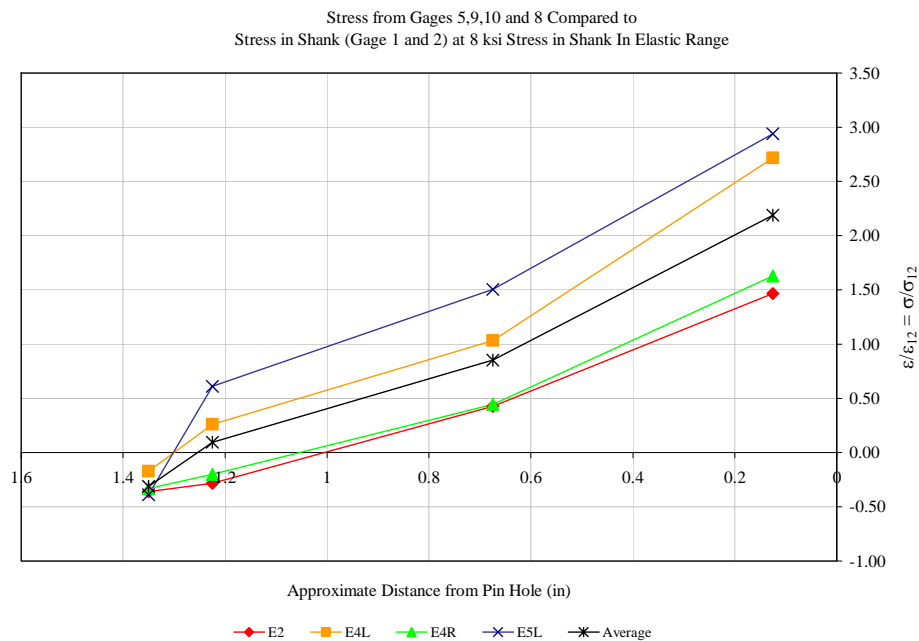
Figure 4.24 Stress Distribution Through Eyebar End Connection Detail

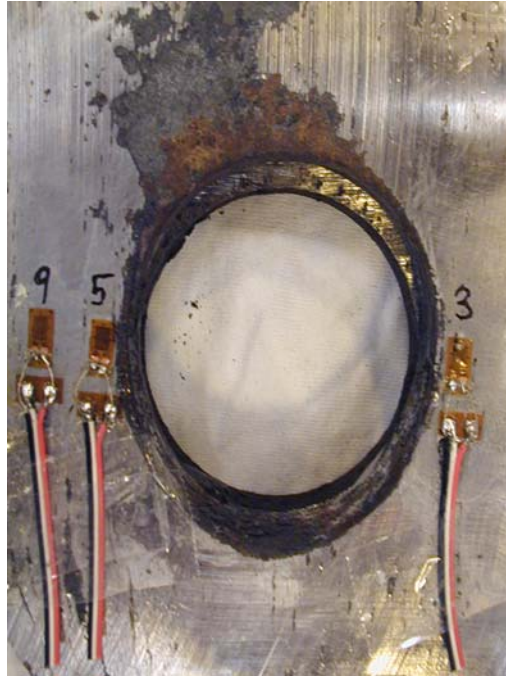
Figure 4.25 Elongation of Hole in Eye Connection after Testing to Failure

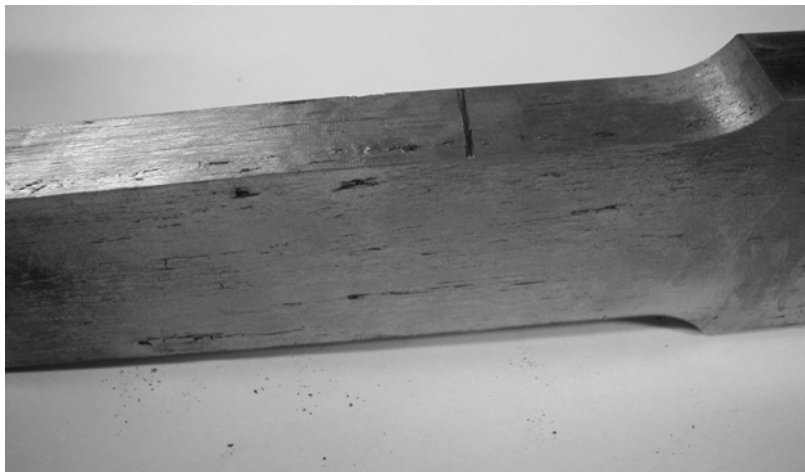
Figure 5.2 Typical Surface Appearance of Wrought Iron in Many Existing Bridges

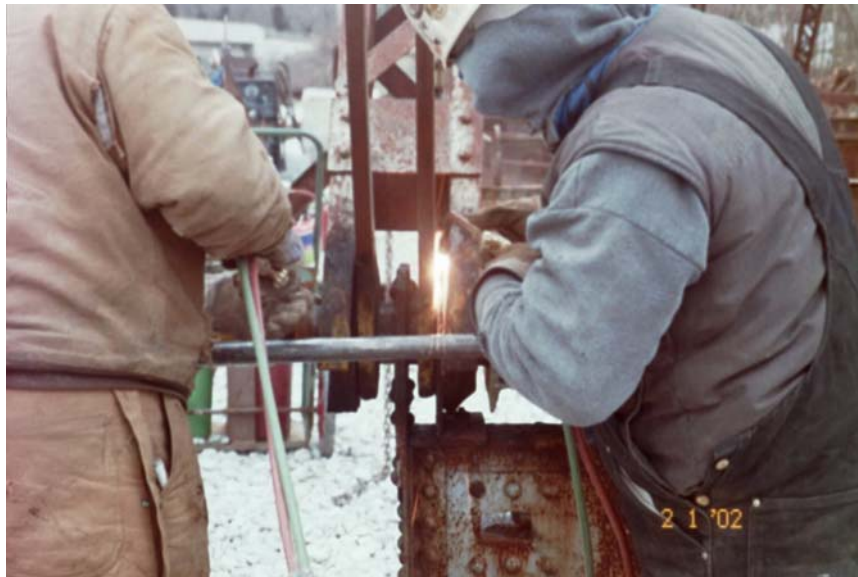
Figure 5.6 Using Heat to Help Remove a Pin During a Rehabilitation of a Bridge In Plainfield, IN.

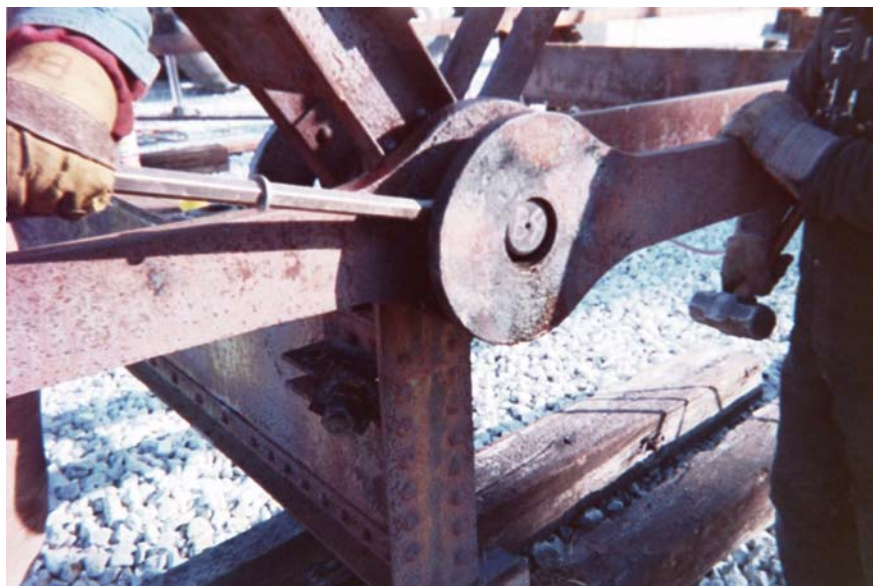
Figure 5.7 Using Force After Using Heat to Disassemble A Pin Connection During a Rehabilitation of a Wrought Iron Bridge In Plainfield, IN.

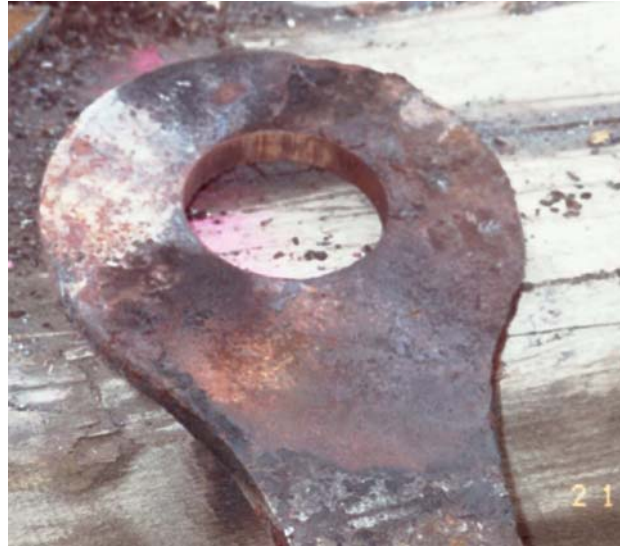
Figure 5.9 Heavy Corrosion in an Eyebar End Connection

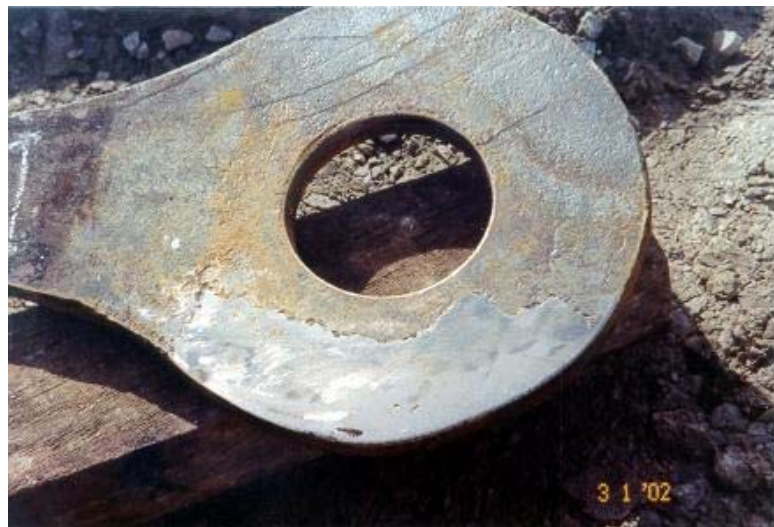
Figure 5.10 Filler Weld Completed in the Field to Repair Corroded Eyebar Connection

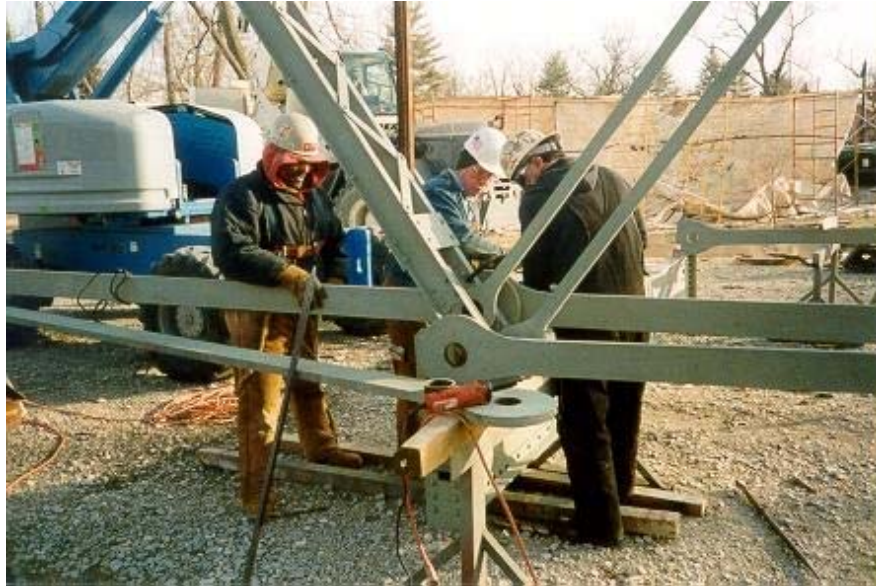
Figure 5.11 Reassembling a Pin Connection After Members Have Been Sand Blasted and Repainted During A Rehabilitation of a Bridge in Plainfield, IN

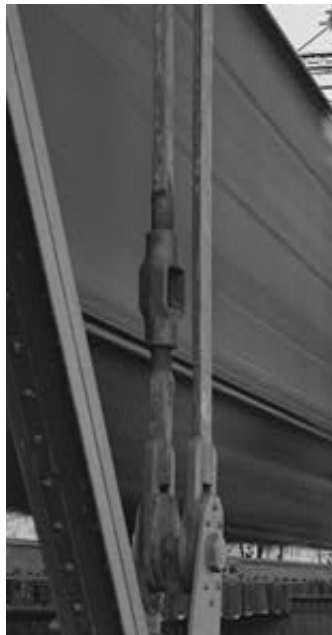
Figure 5.12 Typical Turnbuckle found in and Existing Wrought Iron Bridge (Penn. Railroad, Selinsgrove Bridge, Spanning Susquehanna River, Snyder County, PA - Historic American Buildings Survey/Historic American Engineering Record)

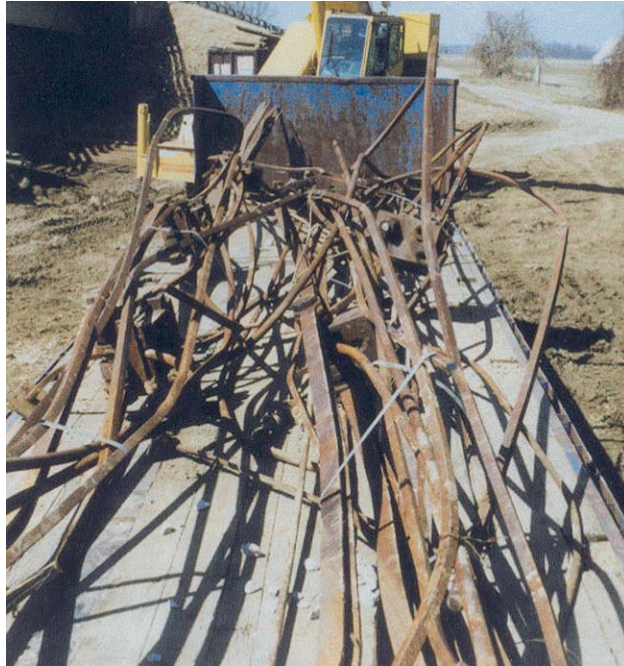
Figure 5.13 Bent and Damaged Members from the Bell Ford Bridge

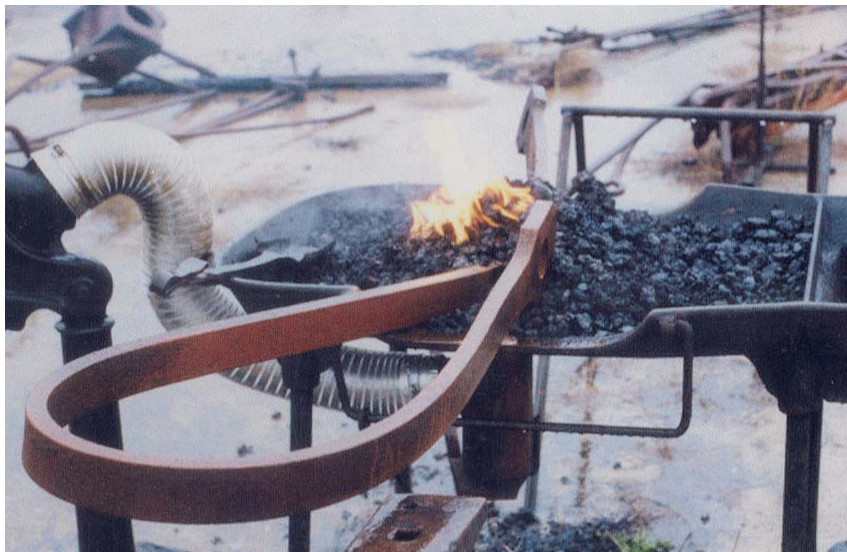
Figure 5.14 Heating and Straightening Damaged Members of the Bell Ford Bridge

Figure 5.14 illustrates the method that was used to heat straighten the eyebars from the Bell Ford Bridge. In this method, the wrought iron is first heated slowly in a

charcoal fire until it is red hot in appearance. When the metal is dark cherry red in color it is typically between 1160 and 1270 °F. After sufficient heating the member is then straightened by bending and/or pounding the surface to work the metal into the desired position. The process may require repeated cycles of heating and pounding to work the metal in the (fluid) red-hot condition. This method is usually performed by a blacksmith and is similar to the original process that was used to form the wrought iron bridge members. To heat the pieces in this manner, the members to be straightened must be removed from the bridge.

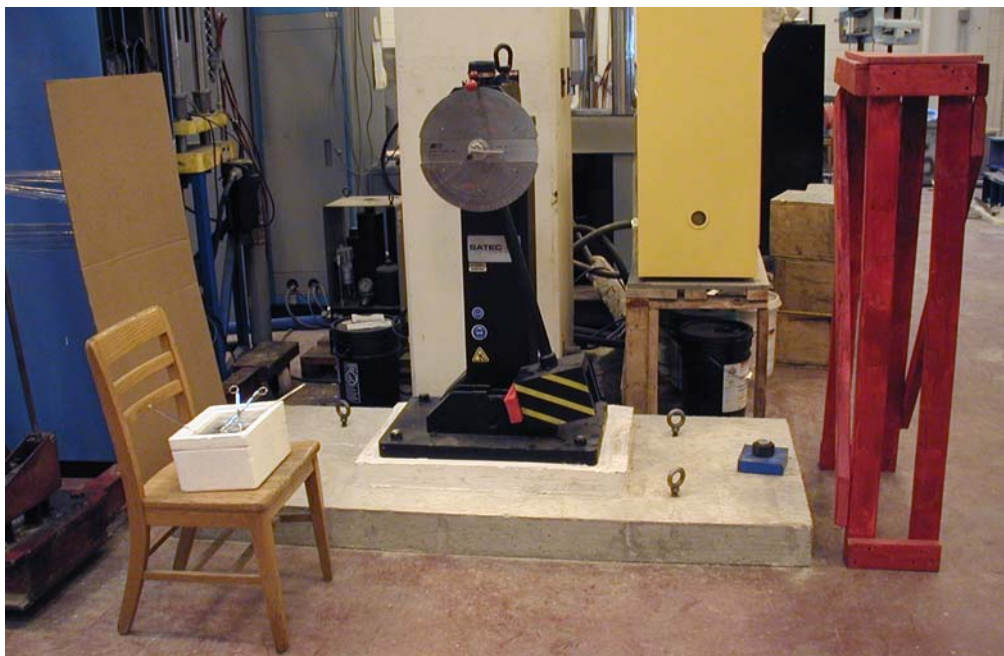
Figure C.17 SATEC Impact Testing Machine Along with Cooling Bath Used in Charpy Impact Testing

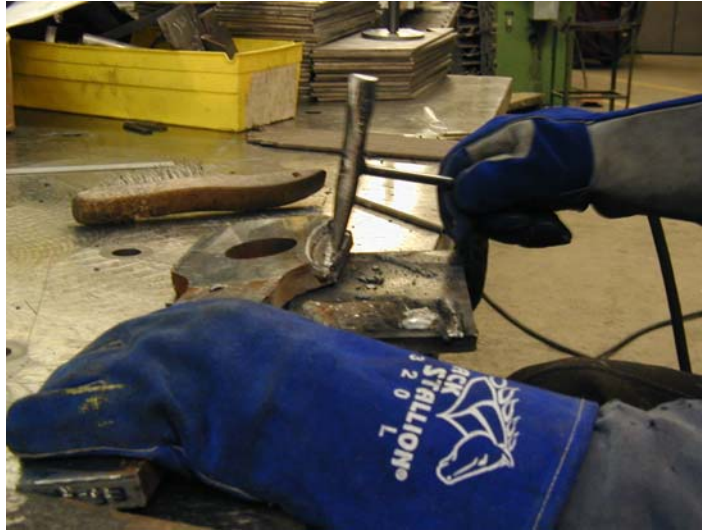
Figure C.25 Chisel Hammer to Remove Surface Slag of Filler Weld in Eyebar End Connection Repair

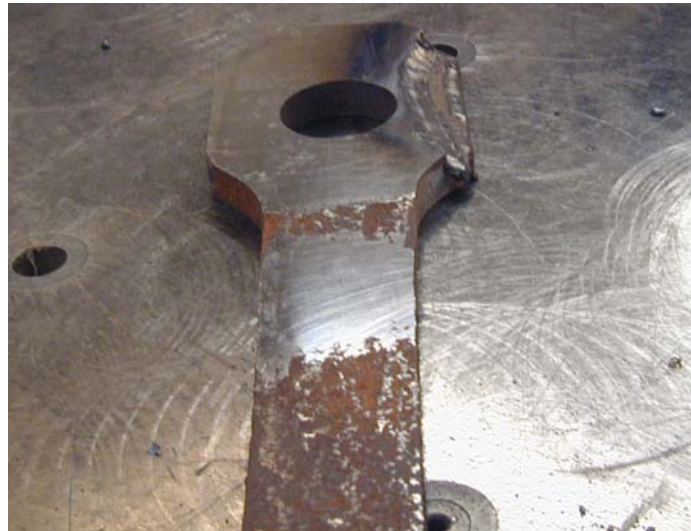
Figure C.26 Eyebar End Connection A after Half of Filler Weld Repair Completed

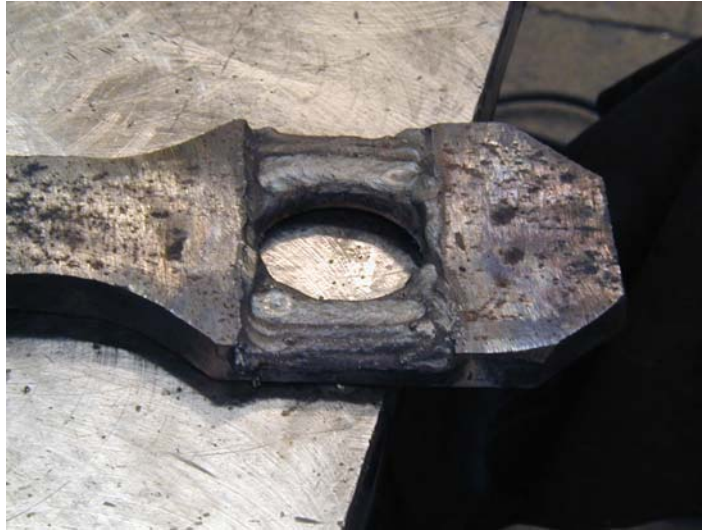
Figure C.27 Eyebar End Connection B after Half of Filler Weld Repair Completed

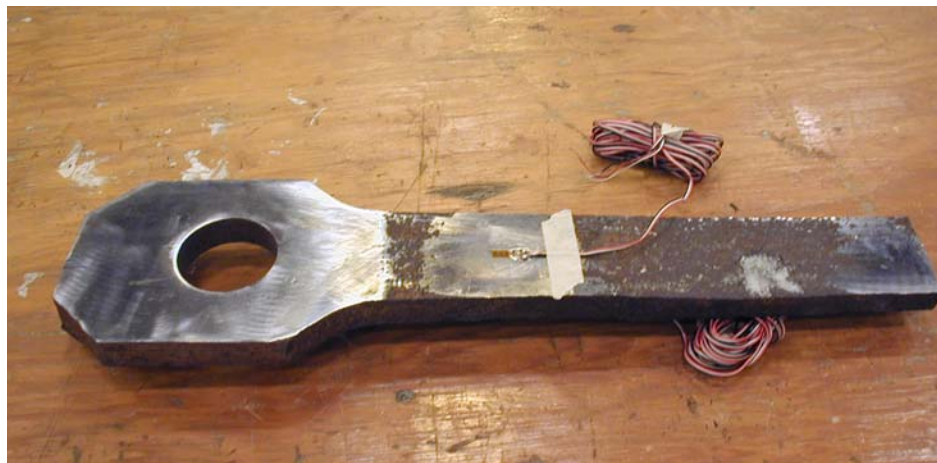
Figure C.28 Eyebar End Connection A after Filler Weld Repair and Surface Grinding Completed

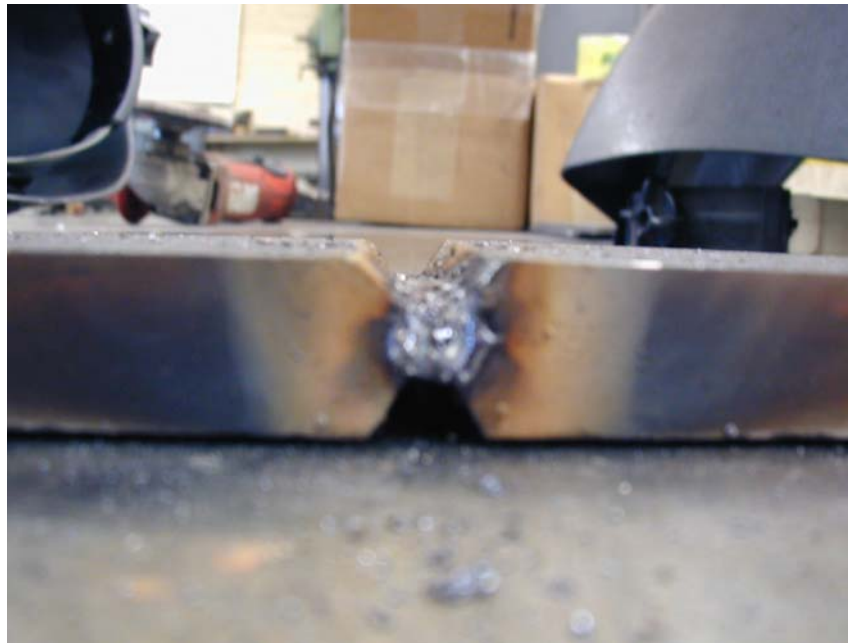
Figure D.2 Weld Joint After Initial Root Pass

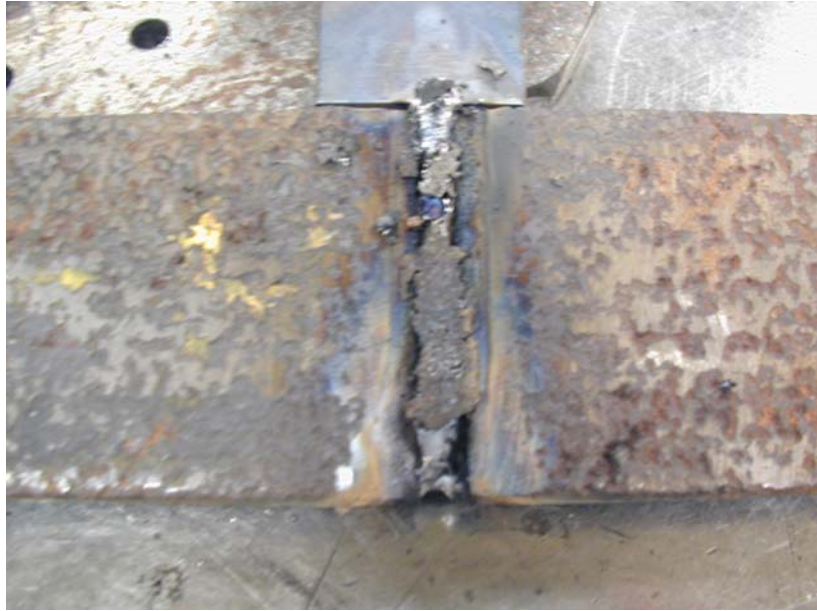
Figure D.3 Surface Impurities or Scale on Surface of Weld
